Forest  
Products  
Laboratory

Research  
Paper  
FPL 433

# Condensation Potential in High Thermal Performance Walls — Cold Winter Climate

by G. E. Sherwood

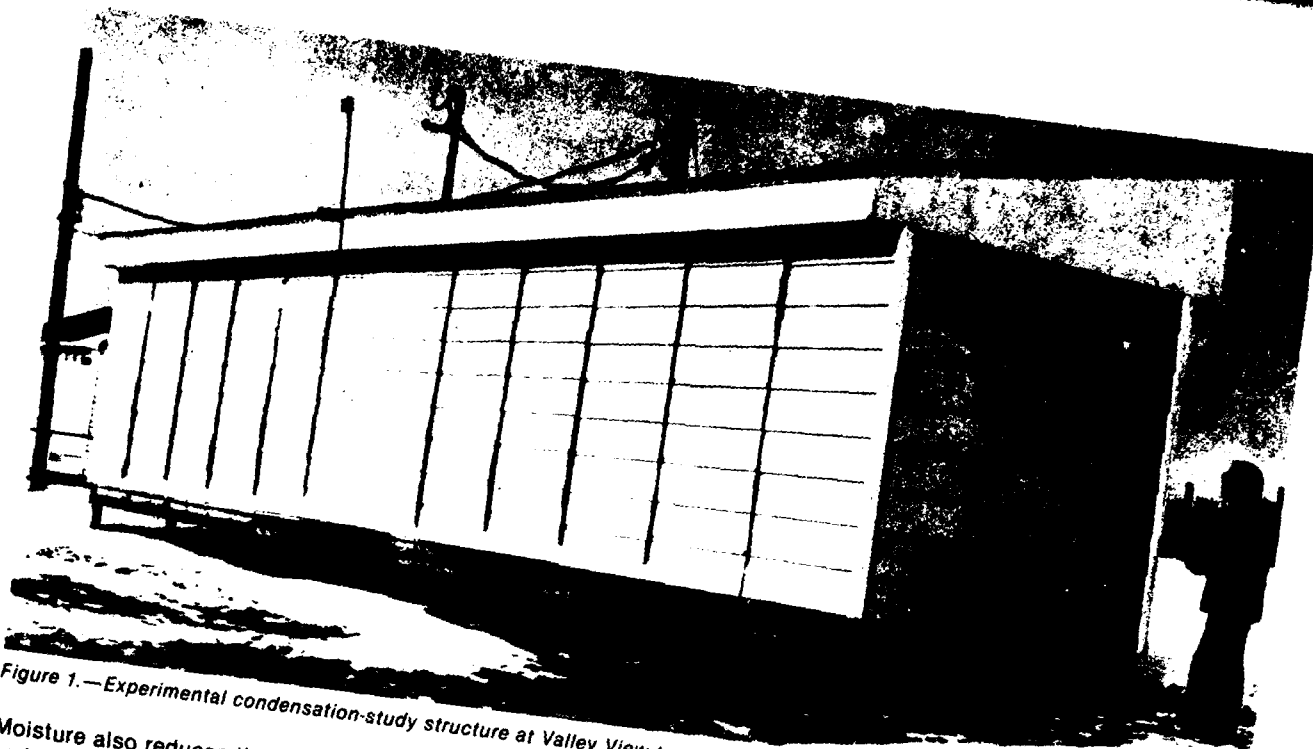
Figure 1.—Experimental condensation-study structure at Valley View test site near Madison, Wis. (M 147 763-11)

The buildings are long and narrow, 8 feet wide by 48 feet long, with the long axis east-west for maximum exposure of north and south walls (fig. 1). The center 8 feet is an instrument room. The remaining length of the building is partitioned every 4 feet resulting in ten 4- by 8-foot rooms (fig. 2) connected by doors in partitions. The only exterior door is in the instrument room. Support for the roof and ceiling is provided by partitions (fig. 3), so exterior wall panels can be removed and replaced while the building remains intact.

After installation of test panels, all joints with floor, ceiling, and partitions were caulked. On the outside, vertical joints between panels were caulked and the joint between floor framing and the bottom edge of the wall panel was caulked. Six-mil polyethylene taped to each face of the partitions extends out between adjoining panels to prevent transfer of moisture between panels (fig. 1).

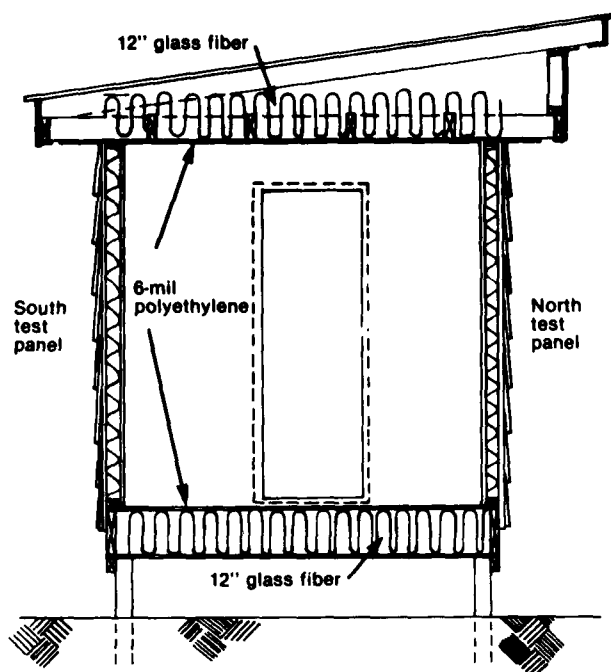
Figure 3.—Cross section of experimental structure showing construction details. (M83 5061)

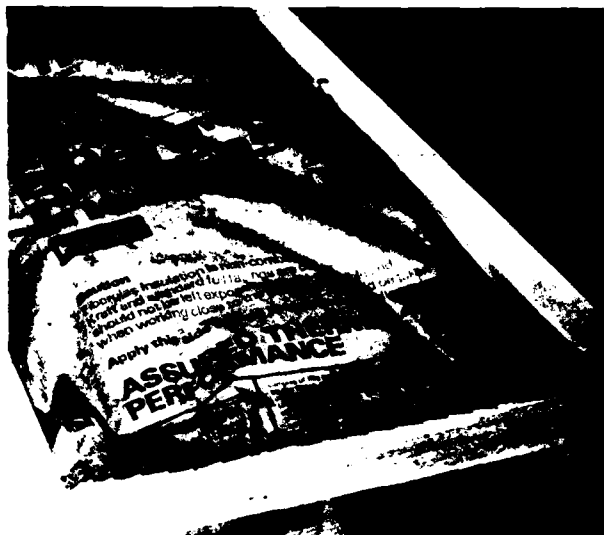
Figure 5.—Asphalted kraft paper vapor retarder stapled to sides of studs. (M 147 191-11)

glass fiber insulation was placed in each wall cavity. One type of panel was framed with 2 by 6 studs at 24-inch spacing. The remaining panels were all framed with 2 by 4 studs at 16-inch spacing. The primary variables are the sheathing material and the vapor retarder (fig. 2). Polystyrene sheathing was in 2- by 4-foot sections, while all other sheathings were 4- by 8-foot sections. Sheathing materials included: 1/2-inch fiberboard, 1/2-inch plywood, 1-inch extruded polystyrene foam, and 1-inch foil-backed glass-fiber reinforced polyisocyanurate foam. Only two types of vapor retarders were used: 6-mil polyethylene film continuous over the face of the framing (fig. 4), or asphalted kraft paper backing on blanket insulation stapled between studs (fig. 5). Although the asphalted kraft paper could be installed by the recommended method of lapping all joints over studs, in field practice it is often stapled between studs with no laps (fig. 5). That method was followed to simulate typical field conditions.

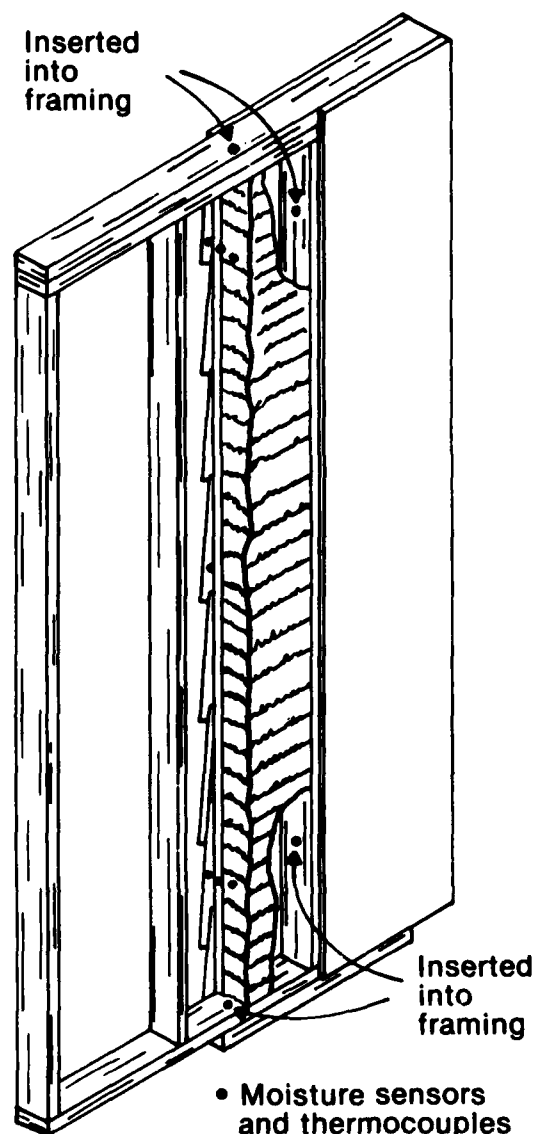
Figure 6.—Moisture sensor locations in each test panel. Four sensors are in framing; two are in the center of insulation; two are at the insulation-sheathing interface; and three are at the sheathing-siding interface. (ML83 5062)

Each test panel was instrumented with moisture sensors at 11 locations in the wall (fig. 6). A thermocouple was also placed at each moisture sensor location. At heights of 1 foot and 7 feet above the floor, moisture measurements were made at the siding-sheathing interface, at the sheathing-insulation interface, at the center of the cavity insulation, and in the adjacent stud. Sensors were also located in the top plate, the sole plate, and between siding and sheathing at the midheight of the wall. Lead wires from all these data points were brought into the room through the vapor retarder and gypsum board at two points (1 foot and 7 feet above the floor). The punctures in the vapor

Moisture conditions were measured at 189 locations (fig. 6) using small wood sensors. The moisture content (MC) of the wood sensor was converted to MC of the members in which they were imbedded, based on the relative humidity of the air in the immediate vicinity. Relative humidity in the rooms, outdoors, and at interfaces between two materials was also recorded.

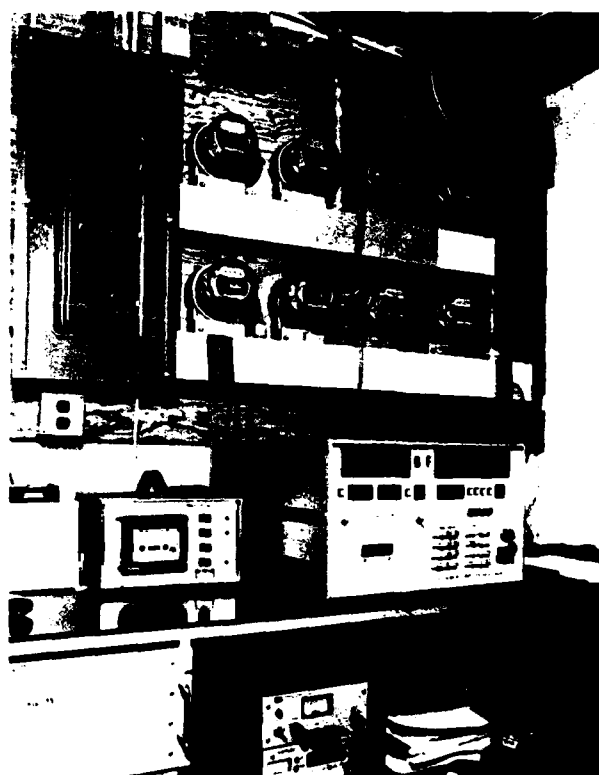
Figure 8.—Instrumentation room showing data logger and electric meters for individual rooms. (M 147 451-11)

All of the moisture and temperature data were digitized and recorded on cassette tape using a multichannel, programmable data logger (fig. 8). Because of equipment malfunctions often caused by local storms, hand readings were required much of the time. Data were collected three times a week.

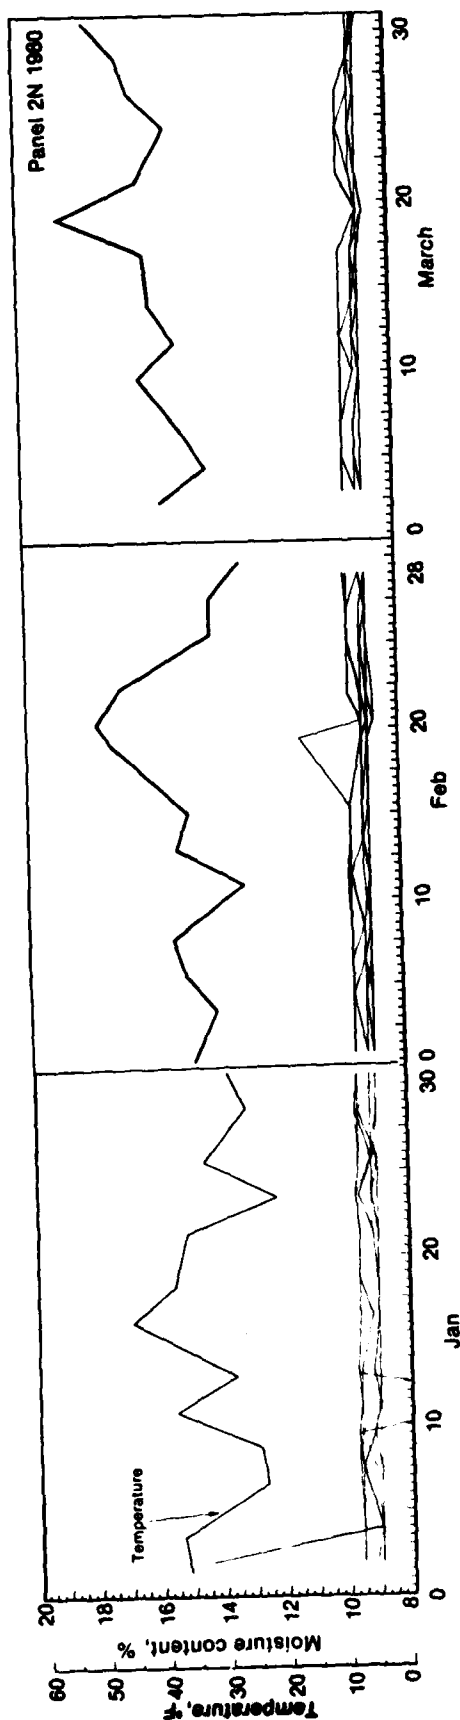
Figure 9. — Moisture content of wood probes in panel 2N (polyethylene, R-13 glass fiber, fiberboard) and corresponding temperature on the warm face of sheathing, January through March 1980. The only probe showing MC exceeding 10 percent was at the insulation-sheathing interface (MLB3 5064)

Three factors affected moisture patterns: 1) type of vapor retarder, 2) permeability of sheathing material, and 3) temperature of sheathing material. Panel 2N (polyethylene, R-13 glass fiber, fiberboard)<sup>5</sup> remained quite dry, with MC at the sheathing rising slightly but not until February (fig. 9). Panel 3N (asphalted paper, R-11 glass fiber, fiberboard), with similar construction but with side-stapled asphalted kraft paper rather than polyethylene vapor retarder, showed high MC's by December (fig. 10). Condensation occurred at the sheathing-siding interface and later at the insulation-sheathing interface. Brown streaking on the siding (figs. 18 and 19) when warm weather followed a period of extreme cold gave visual verification that significant condensation did occur on the back of the siding. Moisture levels also increased somewhat in panel 5N (polyethylene, R-19 glass fiber, fiberboard) (fig. 12), which was similar in construction to 2N except that it had 2 by 6 studs and thicker batt insulation. The thicker insulation resulted in lower sheathing temperature and consequently higher MC as more moisture condensed on the colder surface. However, panel 5N did not exhibit any streaking because the polyethylene vapor retarder limited the amount of moisture entering its wall cavity.

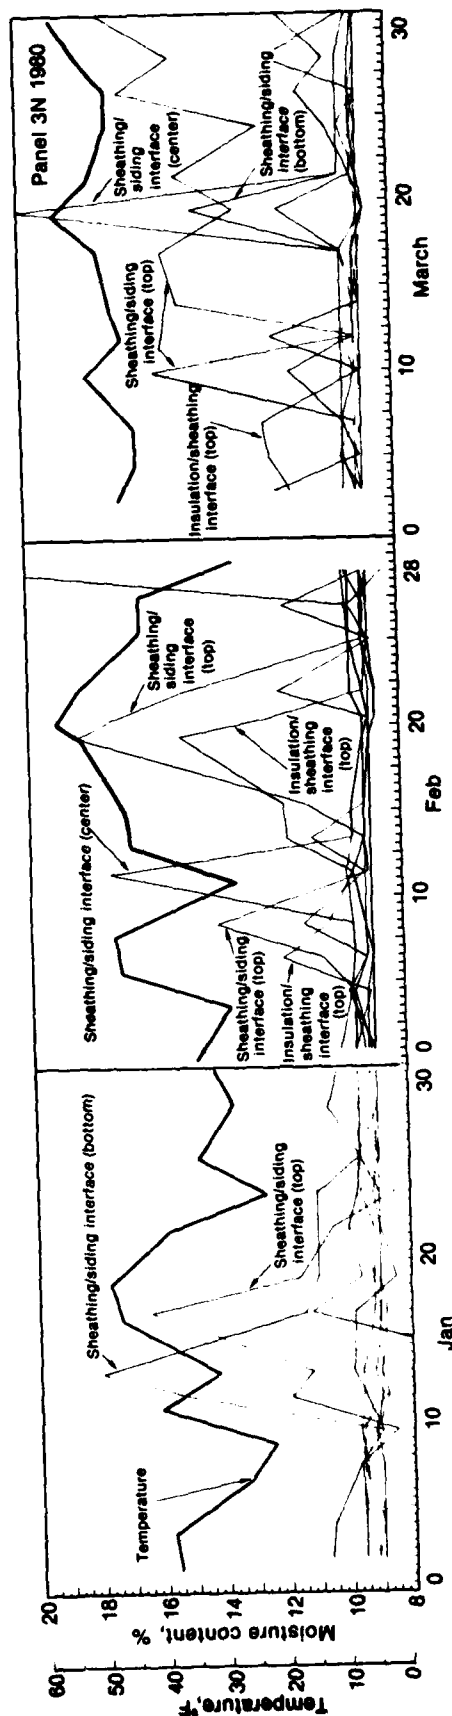
Figure 10. — Moisture content of wood in panel 3N (asphalted paper, R-11 glass fiber, fiberboard) and corresponding temperature on the warm face of sheathing, January through March 1980. (MLB3 5065)

The first high moisture levels occurred in December when temperatures dropped to consistently below freezing levels; the most severe month was February (figs. 9-16). A plot of daily low temperatures during January, February, and March is shown in figure 17. In all cases the northern exposure resulted in higher measured moisture levels than did the southern exposure, so discussion will be primarily directed to the north-wall panels. Three panels (2N, 3N, and 5N) had fiberboard sheathing.

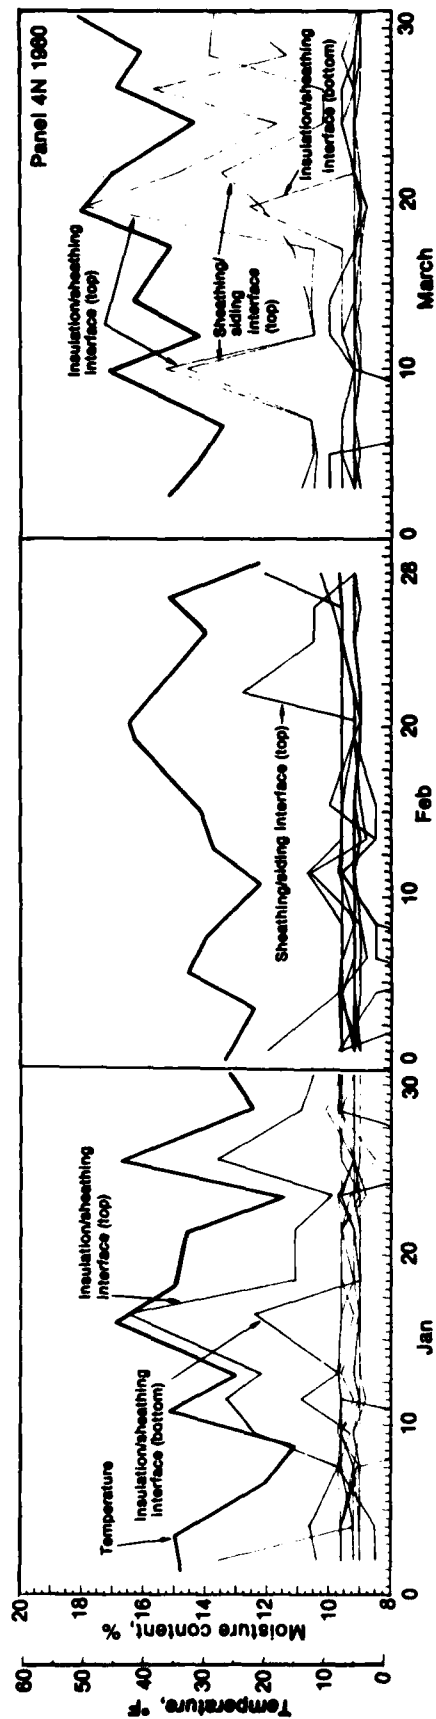
Figure 11. — Moisture content of wood in panel 4N (asphalted paper, R-11 glass fiber, plywood) and corresponding temperature on the warm face of sheathing, January through March 1980. (ML83 5068)

The remaining wall cavities had sheathings resistant to water vapor movement. Panel 4N with plywood sheathing (asphalted paper, R-11 glass fiber, plywood) (fig. 11) had increased MC at the insulation-sheathing interface, but probes did not indicate condensation. The plywood-sheathed panel dried more quickly than did the polystyrene-sheathed panel 7N (fig. 14) when outdoor temperatures increased, possibly because it was able to absorb and redistribute the moisture present. Panel 4N, however, had no brown streaking on its siding as wall cavity moisture could not readily move through the plywood sheathing to the siding. Panel 7N (asphalted paper, R-11 glass fiber, polystyrene) had condensation on the sheathing from mid-February through March and had very slight streaking of the siding, probably because sufficient

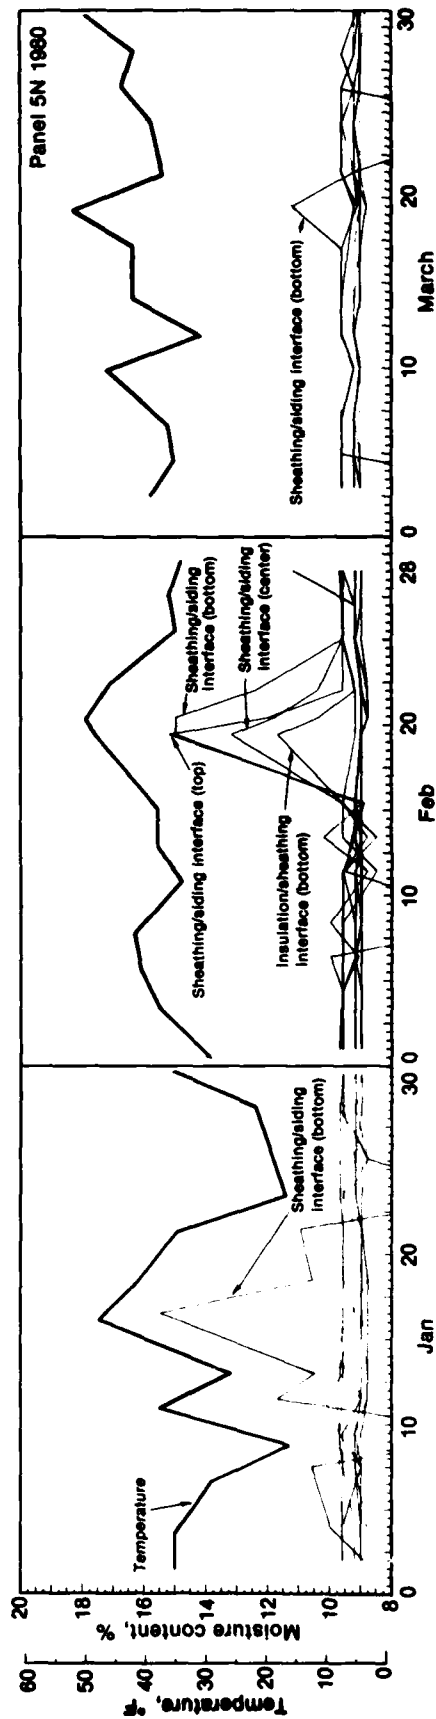
Figure 12. — Moisture content of wood probes in panel 5N (polyethylene, R-19 glass fiber, fiberboard) and corresponding temperature on the warm face of sheathing, January through March 1980. (ML83 5067)

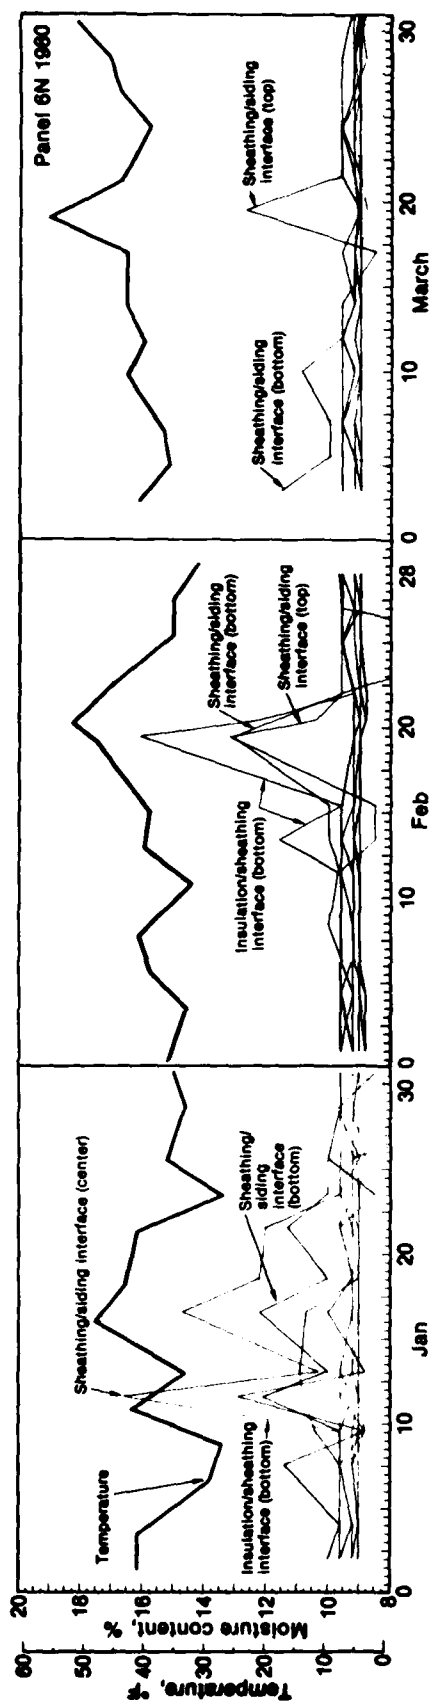
Figure 13. — Moisture content of wood probes in panel 6N (polyethylene, R-13 glass fiber, polystyrene) and corresponding temperature on the warm face of sheathing, January through March 1980. (ML83 5068)

Wall cavities with both polyethylene vapor retarder and low-permeance foam sheathing had no indication of condensation. Moisture content at the insulation-sheathing interface in the wall with polystyrene sheathing (6N) (fig. 13) did rise significantly by December and remained high until March. Both walls with foil-backed foam (8N, 9N) had increases in MC at the insulation-sheathing interface only during periods of extreme cold in January and February (figs. 15 and 16).

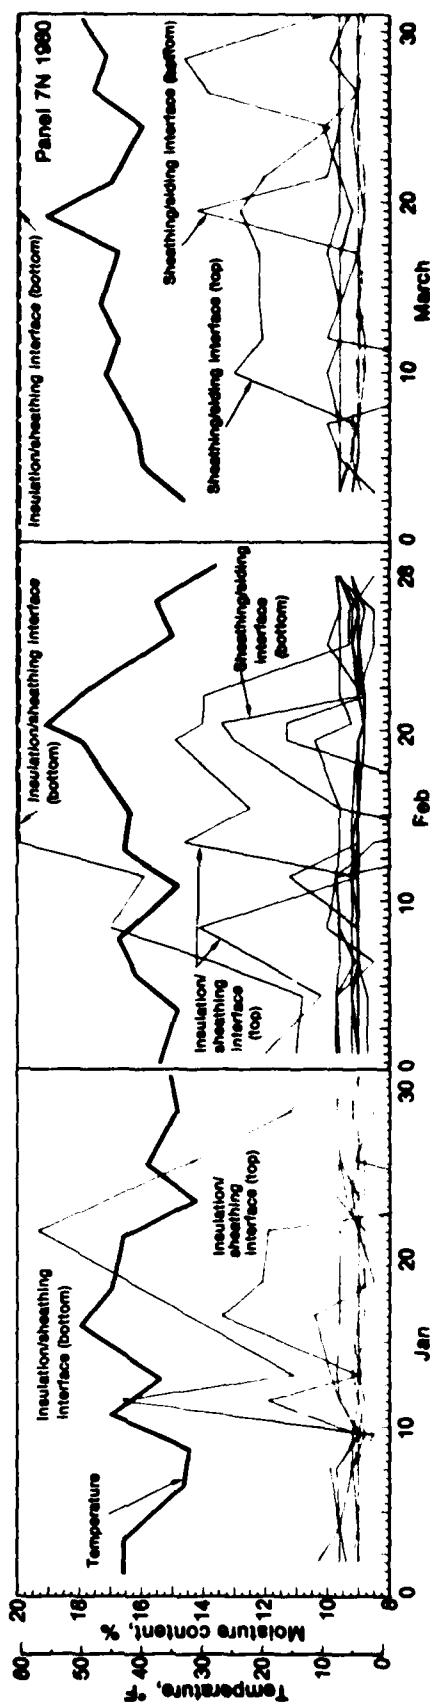
Figure 14. — Moisture content of wood probes in panel 7N (asphalted paper, R-11 glass fiber, polystyrene) and corresponding temperature on the warm face of sheathing, January through March 1980. (ML83 5069)

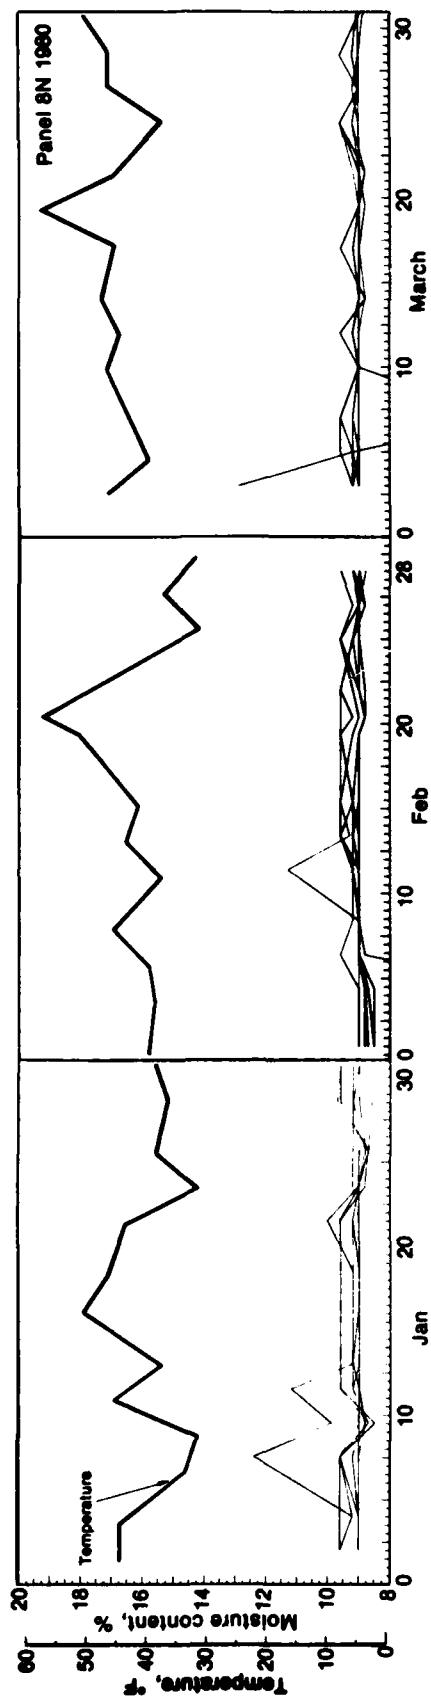
Figure 15. — Moisture content of wood probes in panel 8N (polyethylene, R-13 glass fiber, vented foil-backed isocyanurate) and corresponding temperature on the warm face of sheathing, January through March 1980. The only probe showing MC exceeding 10 percent was at the insulation-sheathing interface (top). (ML83 5070)

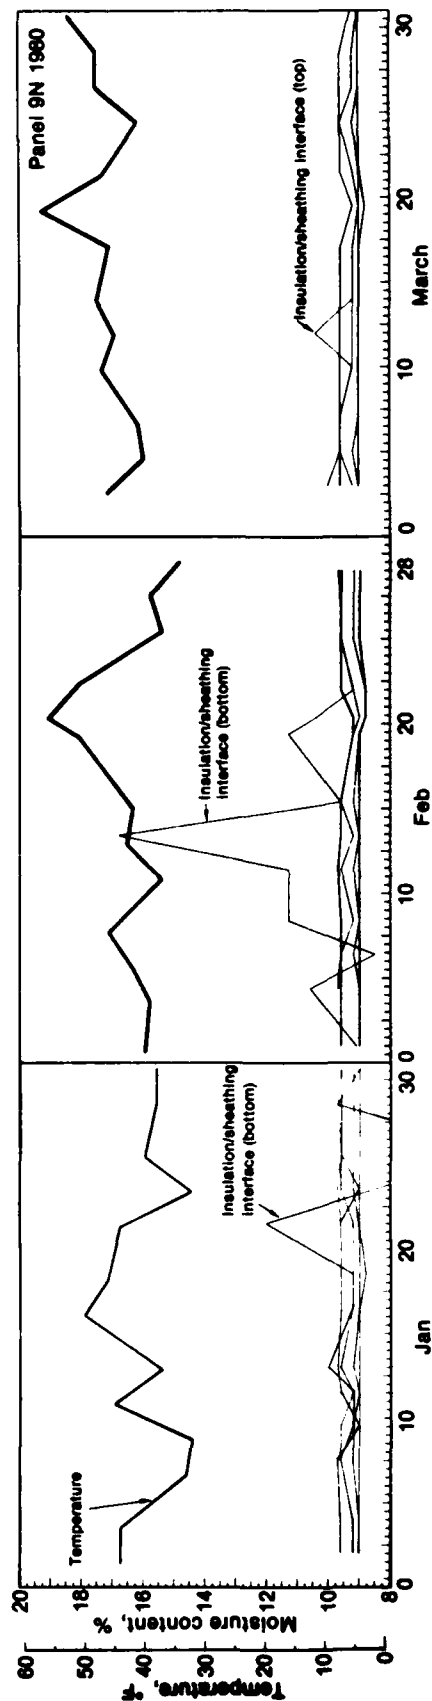
Figure 16. — Moisture content of wood probes in panel 9N (polyethylene, R-13 glass fiber, foil-backed isocyanurate) and corresponding temperature on the warm face of sheathing, January through March 1980. (ML83 5071)

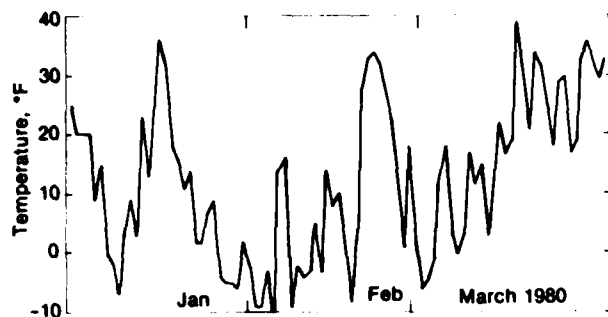
Figure 17.—Daily low temperatures for January through March 1980. (ML 83 5072)

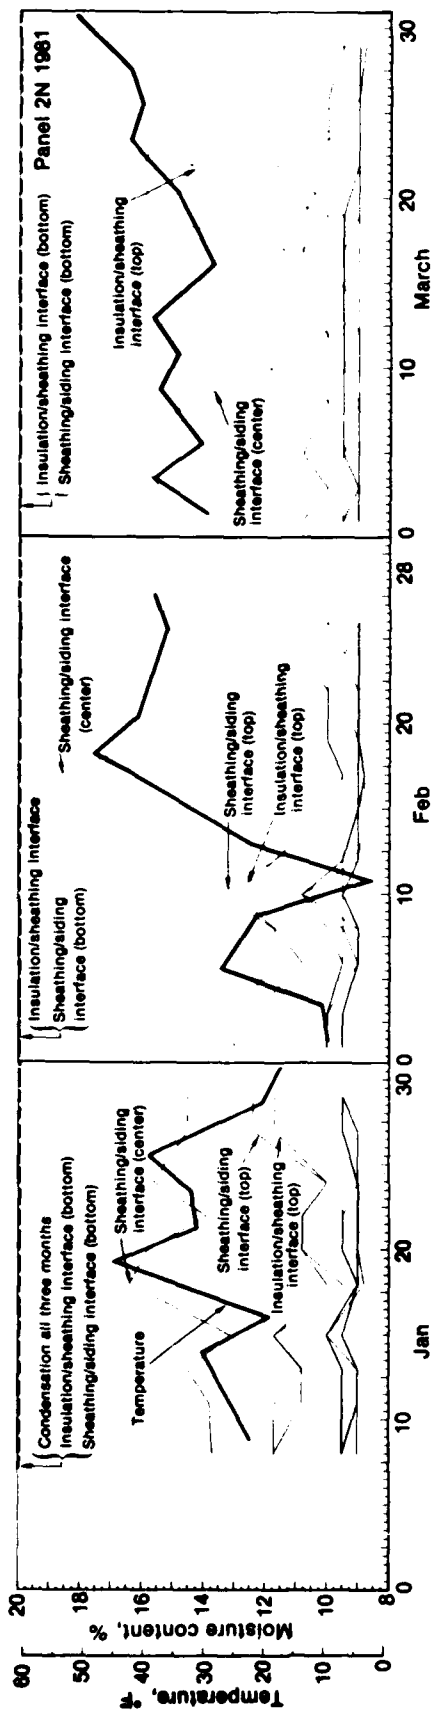
Figure 20. — Moisture content of wood probes in panel 2N (polyethylene, R-13 glass fiber, fiberboard) and corresponding temperature on the warm face of sheathing, January through March 1981. (ML83 5073)

Moisture in all north panels during January, February, and March 1981 is plotted in figures 20 through 27. Temperatures at the insulation-sheathing interface are also shown for each panel. Daily low temperature during January, February, and March is plotted in figure 28.

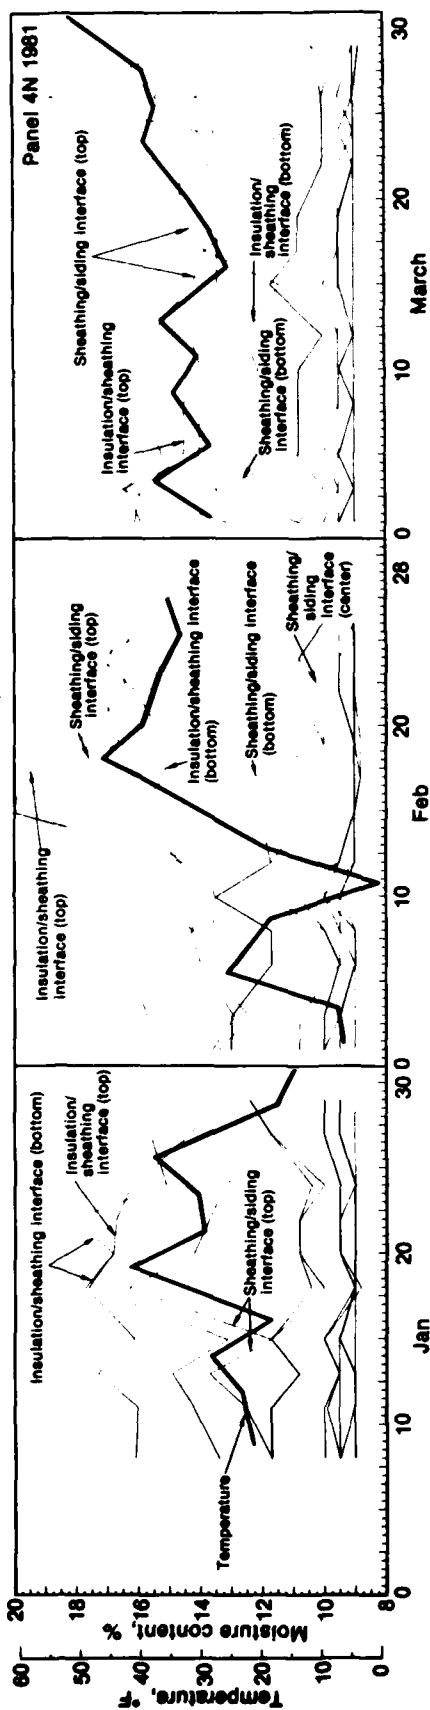
Figure 22. — Moisture content of wood probes in panel 4N (asphalted paper, R-11 glass fiber, plywood) and corresponding temperature on the warm face of sheathing, January through March 1981. (ML83 5075)

Panels 4N (asphalted paper, R-11 glass fiber, plywood) and 5N (polyethylene, R-19 glass fiber, fiberboard) (figs. 22 and 23) also had extended periods when condensation was apparently present on the sheathing near the top of the wall. Because these two types of walls indicate the lowest sheathing temperatures, condensation could occur at lower cavity humidity conditions than in any other wall tested. The warmest and coldest sheathing temperatures for January, February, and March 1981 (fig. 29) illustrated a range of up to 20° F temperature difference at this critical interface for the various types of construction.

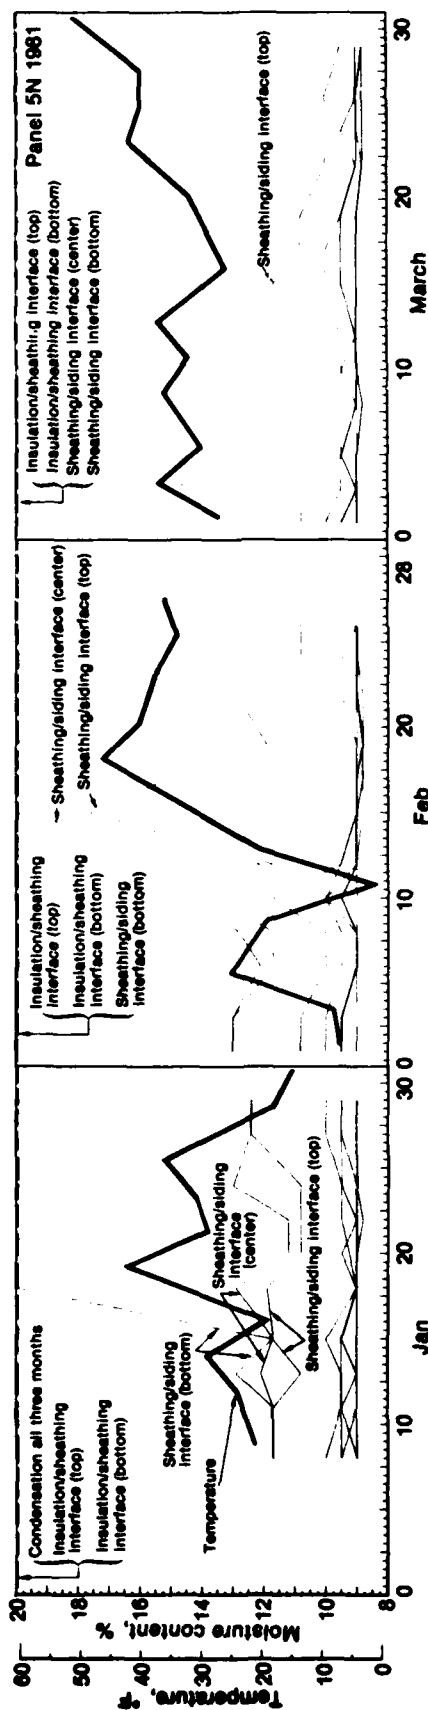
Figure 23. — Moisture content of wood probes in panel 5N (polyethylene, R-19 glass fiber, fiberboard) and corresponding temperature on the warm face of sheathing, January through March 1981. (ML83 5076)

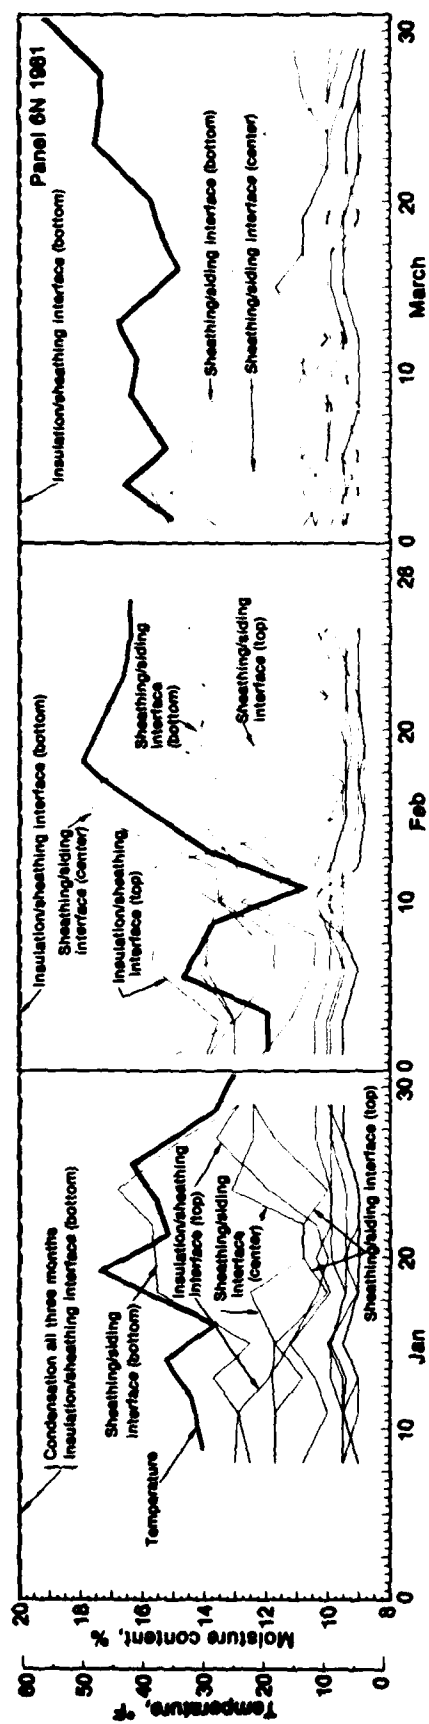
Figure 24. —Moisture content of wood probes in panel 6N (polyethylene, R-13 glass fiber, polystyrene) and corresponding temperature on the warm face of sheathing, January through March 1981. (MLB3 5017)

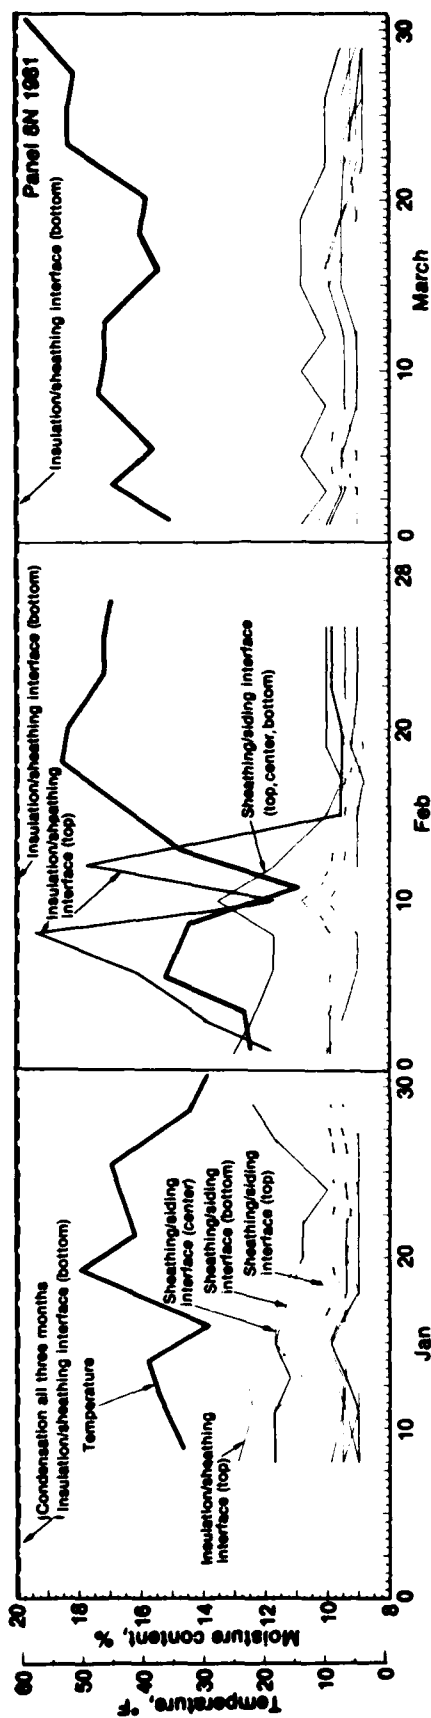
Figure 26. — Moisture content of wood probes in panel 8N (polyethylene, R-13 glass fiber, vented foil-backed isocyanurate) and corresponding temperature on the warm face of sheathing, January through March 1981. (ML83 5079)

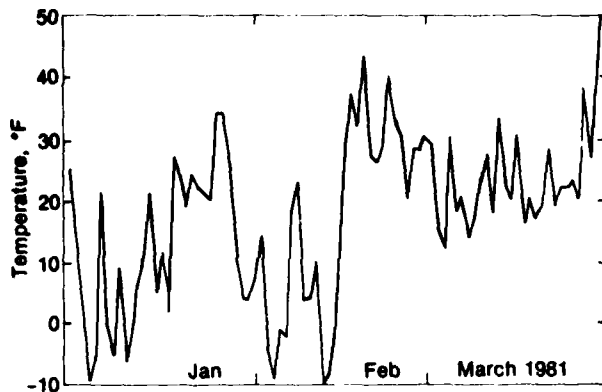
Figure 28.—Daily low temperatures for January through March 1981. (MLB3 5081)

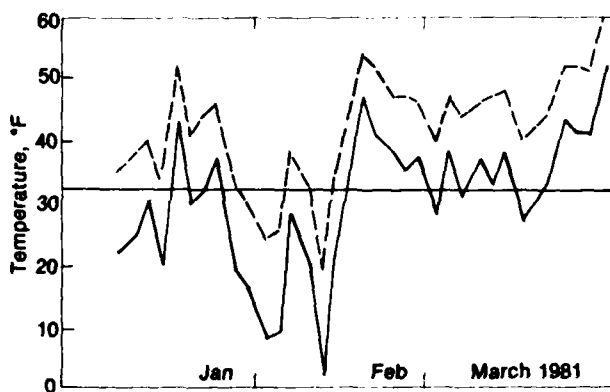
Figure 29.—Warmest and coldest north-side sheathing temperatures (panels 5N and 9N) for January through March 1981. (MLB3 5082)
